DEPARTMENT OF TRANSPORTATION

Quality Assurance and Source Inspection

WELDING INSPECTION REPORT

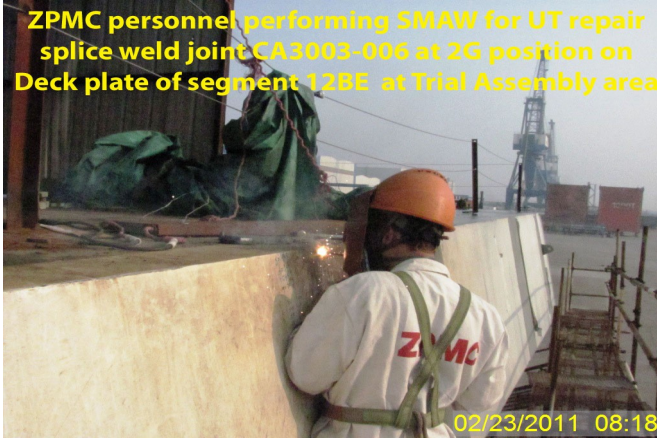
SMAW in the 2G position for the OBG Segment 12BE, UT repair weld No. CA3003-006. The welder is identified

as #044504. ZPMC QC is identified as Mr. Wang Li Yang. The welding variables recorded by QC appear to comply with WPS-345-SMAW-2G(2F)-FCM-REPAIR-1. The weld repair report is identified as CWR2808. The welding variables were recorded at, Amperage 164, volts 24.5. The In-process SMAW appears to be progressing in compliance with approved contract documents.

ZPMC personnel performing SMAW for UT repair
splice weld joint CA3003-006 at 2G position on
Deck plate of segment 12BE at Trial Assembly area
